Quench Water Cooler Performance Improvement

Industry: Chemical
Application: Quench Water Cooler
Location: USA
Year of installation: 1998

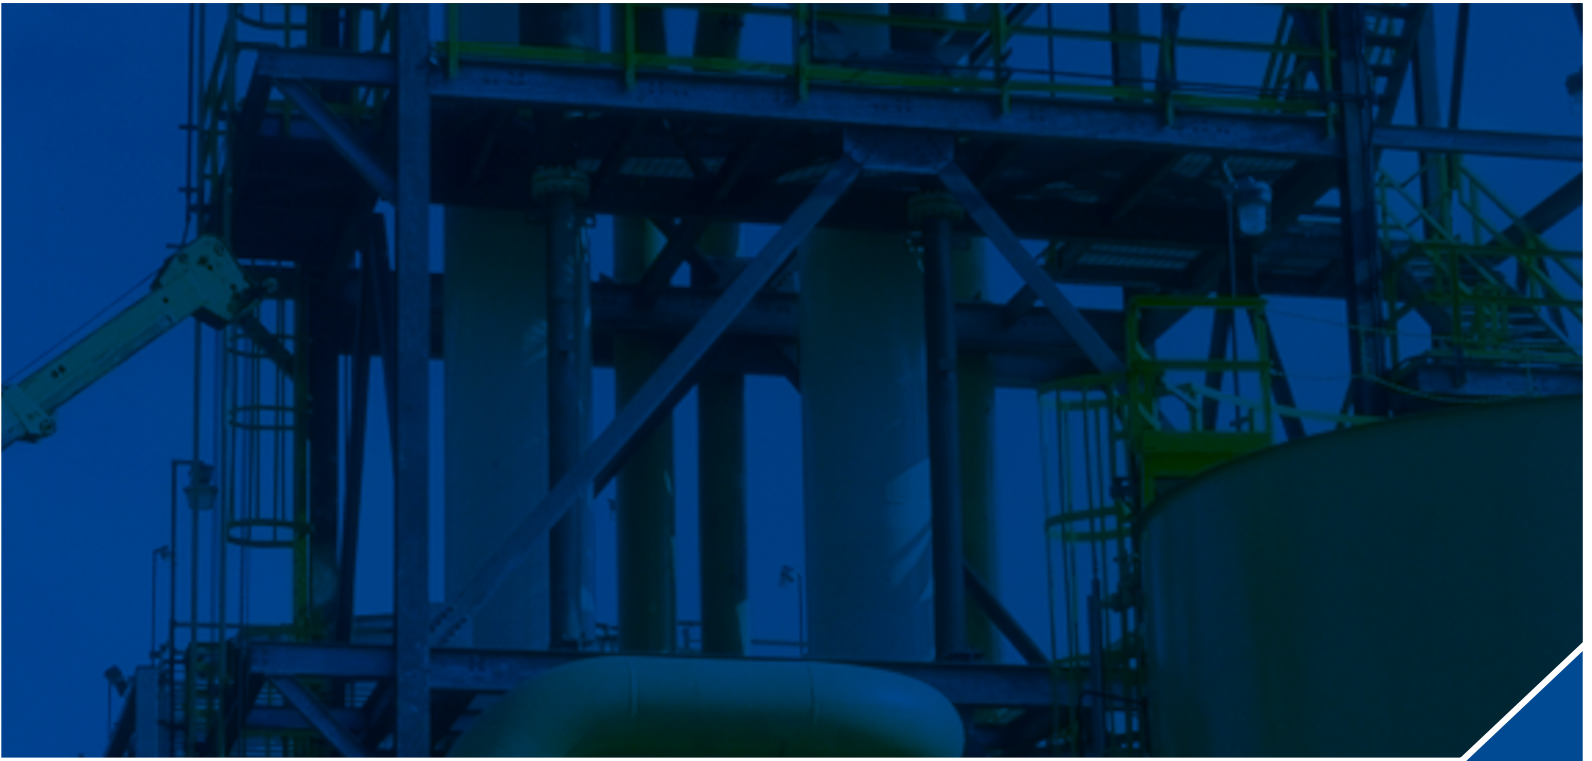
A test with the self-cleaning heat exchanger technology was done to prove the performance. After this test, 4 self-cleaning heat exchangers, applying recirculation of cleaning particles with fluid velocity of 0.45 m/s and a heat transfer surface of 1,250 m² each, were installed. A large storage vessel maintains a constant liquid flow into the self-cleaning heat exchangers. After 3 years of operation, the plant went bankrupt and stopped the production of acetylene.

- No cleanings per year required compared to the 12 cleanings per year with the conventional heat exchangers.
- Heat transfer increased due to the cleaning particles from 1600 W/m²K to 3000 W/m²K with a 10% volume fraction of the particles in the tubes
- Heat exchange surface reduced from 24,000 m² with conventional heat exchangers to 5,000m² with the self-cleaning configuration.
- Pumping power reduced from 2100kW to 850kW due to lower liquid velocity
